# Manhole Inspection Summary

Manhole # S15EE1026MH

**Location** Address: **2450 SHIRLEY AVE**

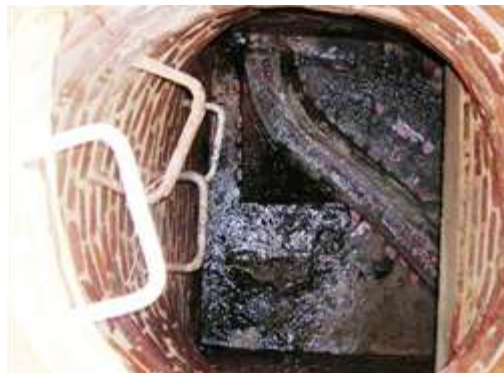
Top View

Corroded steps. Evidence of surcharge - Bench debris.

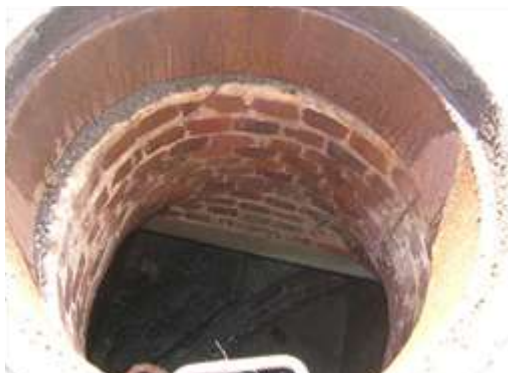
Defect

Frame leaks. Adjustment and Barrel infiltration.

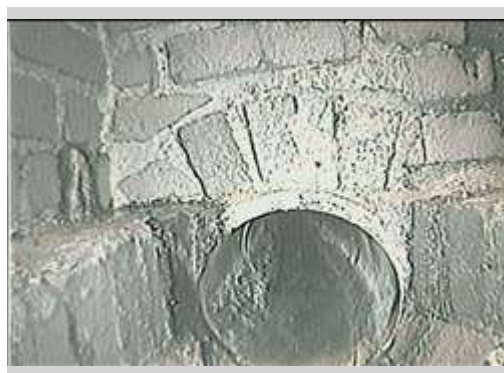
Defect

Barrel infiltration.

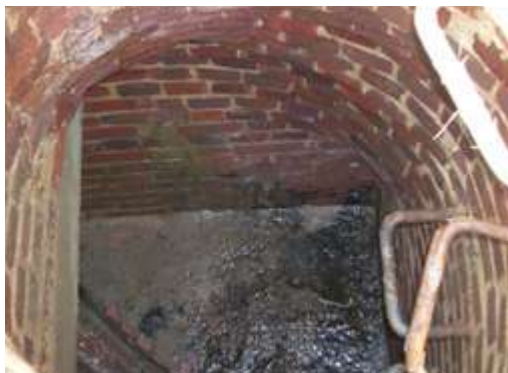
Defect

Barrel infiltration. Bench debris.

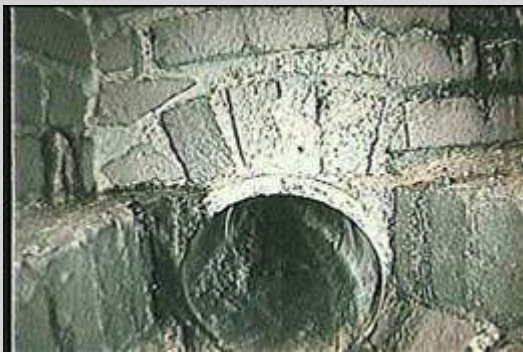
### 8 in. Circular Gravity Sewer Pipe Out @ 12 O'Clock

Deposits: ☐ None ☐ Mud ☐ Sludge ☐ Debris ☒ Grease

Silt Depth: **0** (in.) Deposits Extent: **Light**

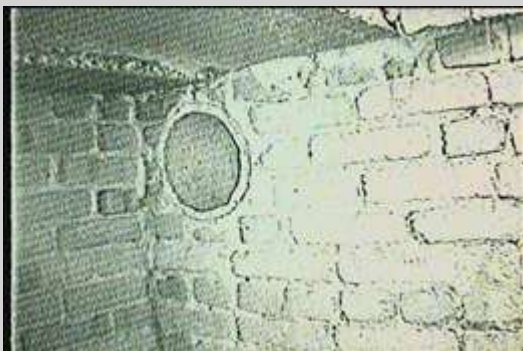
### 8 in. Circular Gravity Sewer Pipe In @ 5 O'Clock

Infiltration: **Evidence** Pipe Seal Cond: **Cracked**
